APPLICATION NOTE

# Cause and Location of Delamination of Multi-layer Metal Foil by XPS

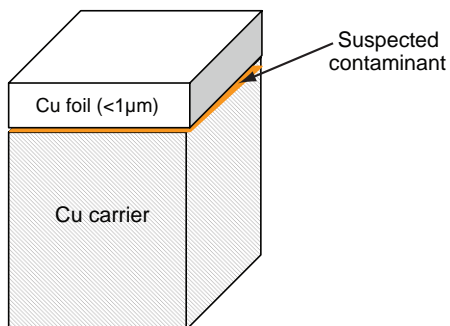
Determining the locus of failure in multilayer laminates is often the first step in understanding the cause of failure. In many cases a fraction of a monolayer of contamination is enough to weaken a bond to the point of failure. In this example we examine mating faces from a failed Cu-laminate (see the figure below). X-ray photoelectron spectroscopy (XPS) is used because of its surface sensitivity and ability to quantitatively identify not only the elements present but also determine their chemical or oxidation states.

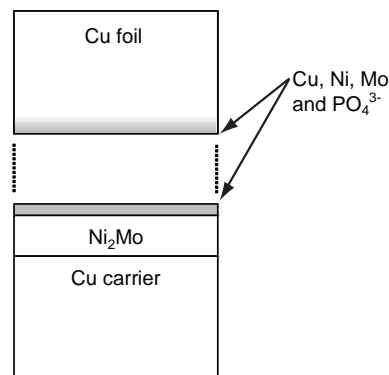
**Schematic of laminate structure and failure location based on XPS data**

XPS was used to determine that adhesive failure occurred at a Ni<sub>2</sub>Mo-Cu interface as a result of a high concentration of phosphate (see schematic in lower right).
