APPLICATION NOTE

# Cause and Location of Delamination of Multi-layer Metal Foil by XPS

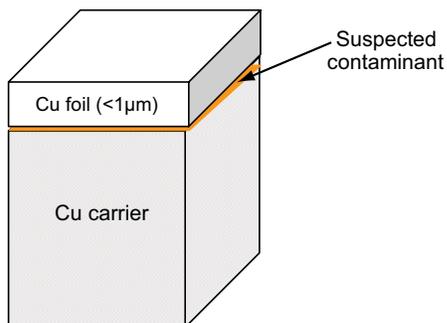
Determining the locus of failure in multilayer laminates is often the first step in understanding the cause of failure. In many cases a fraction of a monolayer of contamination is enough to weaken a bond to the point of failure. In this example we examine mating faces from a failed Cu-laminate (see the figure below). X-ray photoelectron spectroscopy (XPS) is used because of its surface sensitivity and ability to quantitatively identify not only the elements present but also determine their chemical or oxidation states.

As expected, copper was detected on both sides of the failed interface. Significant quantities of Ni<sup>0</sup>, Ni<sup>3+</sup>, Mo<sup>0</sup>, Mo<sup>4+</sup>, Mo<sup>6+</sup> and PO<sub>4</sub><sup>3-</sup> were detected on both sides of the failed interface by XPS. Carbon was also detected, but likely came from adsorption of organic species during air exposure prior to analysis.

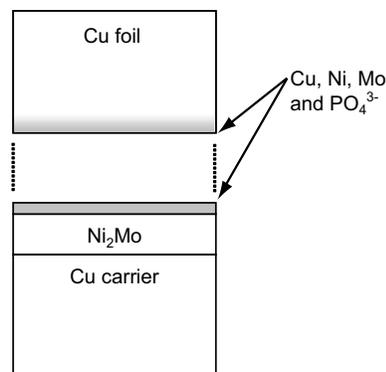
To probe the thickness of the Ni, Mo and P containing layers, the exposed surfaces were depth profiled using an argon ion beam. The resulting profiles reveal a roughly 10Å thick phosphate layer on both sides of the failed interface. The P concentration is relatively low (2.5%); however, it was determined to be present as PO<sub>4</sub><sup>3-</sup>, meaning the total amount of phosphate at the interface is >5X the P concentration. The cation associated with the phosphate was likely either Cu, Mo or possibly H (hydrogen is not detected by XPS). Beneath the phosphate layer on the Carrier side was a ~100Å thick Ni<sub>2</sub>Mo layer. A small amount of Ni was detected on the mating foil surface.

XPS was used to determine that adhesive failure occurred at a Ni<sub>2</sub>Mo-Cu interface as a result of a high concentration of phosphate (see schematic in lower right).

**Schematic of laminate structure and failure location based on XPS data**
