Failure Analysis of Particle Contamination in Battery

By Yuanqin (Daniel) Liu, Kelly Prochaska, Dogancan Sari, and Dr. Daniel J. D. Sullivan, Eurofins EAG Laboratories, Sunnyvale, CA, USA
www.eag.com

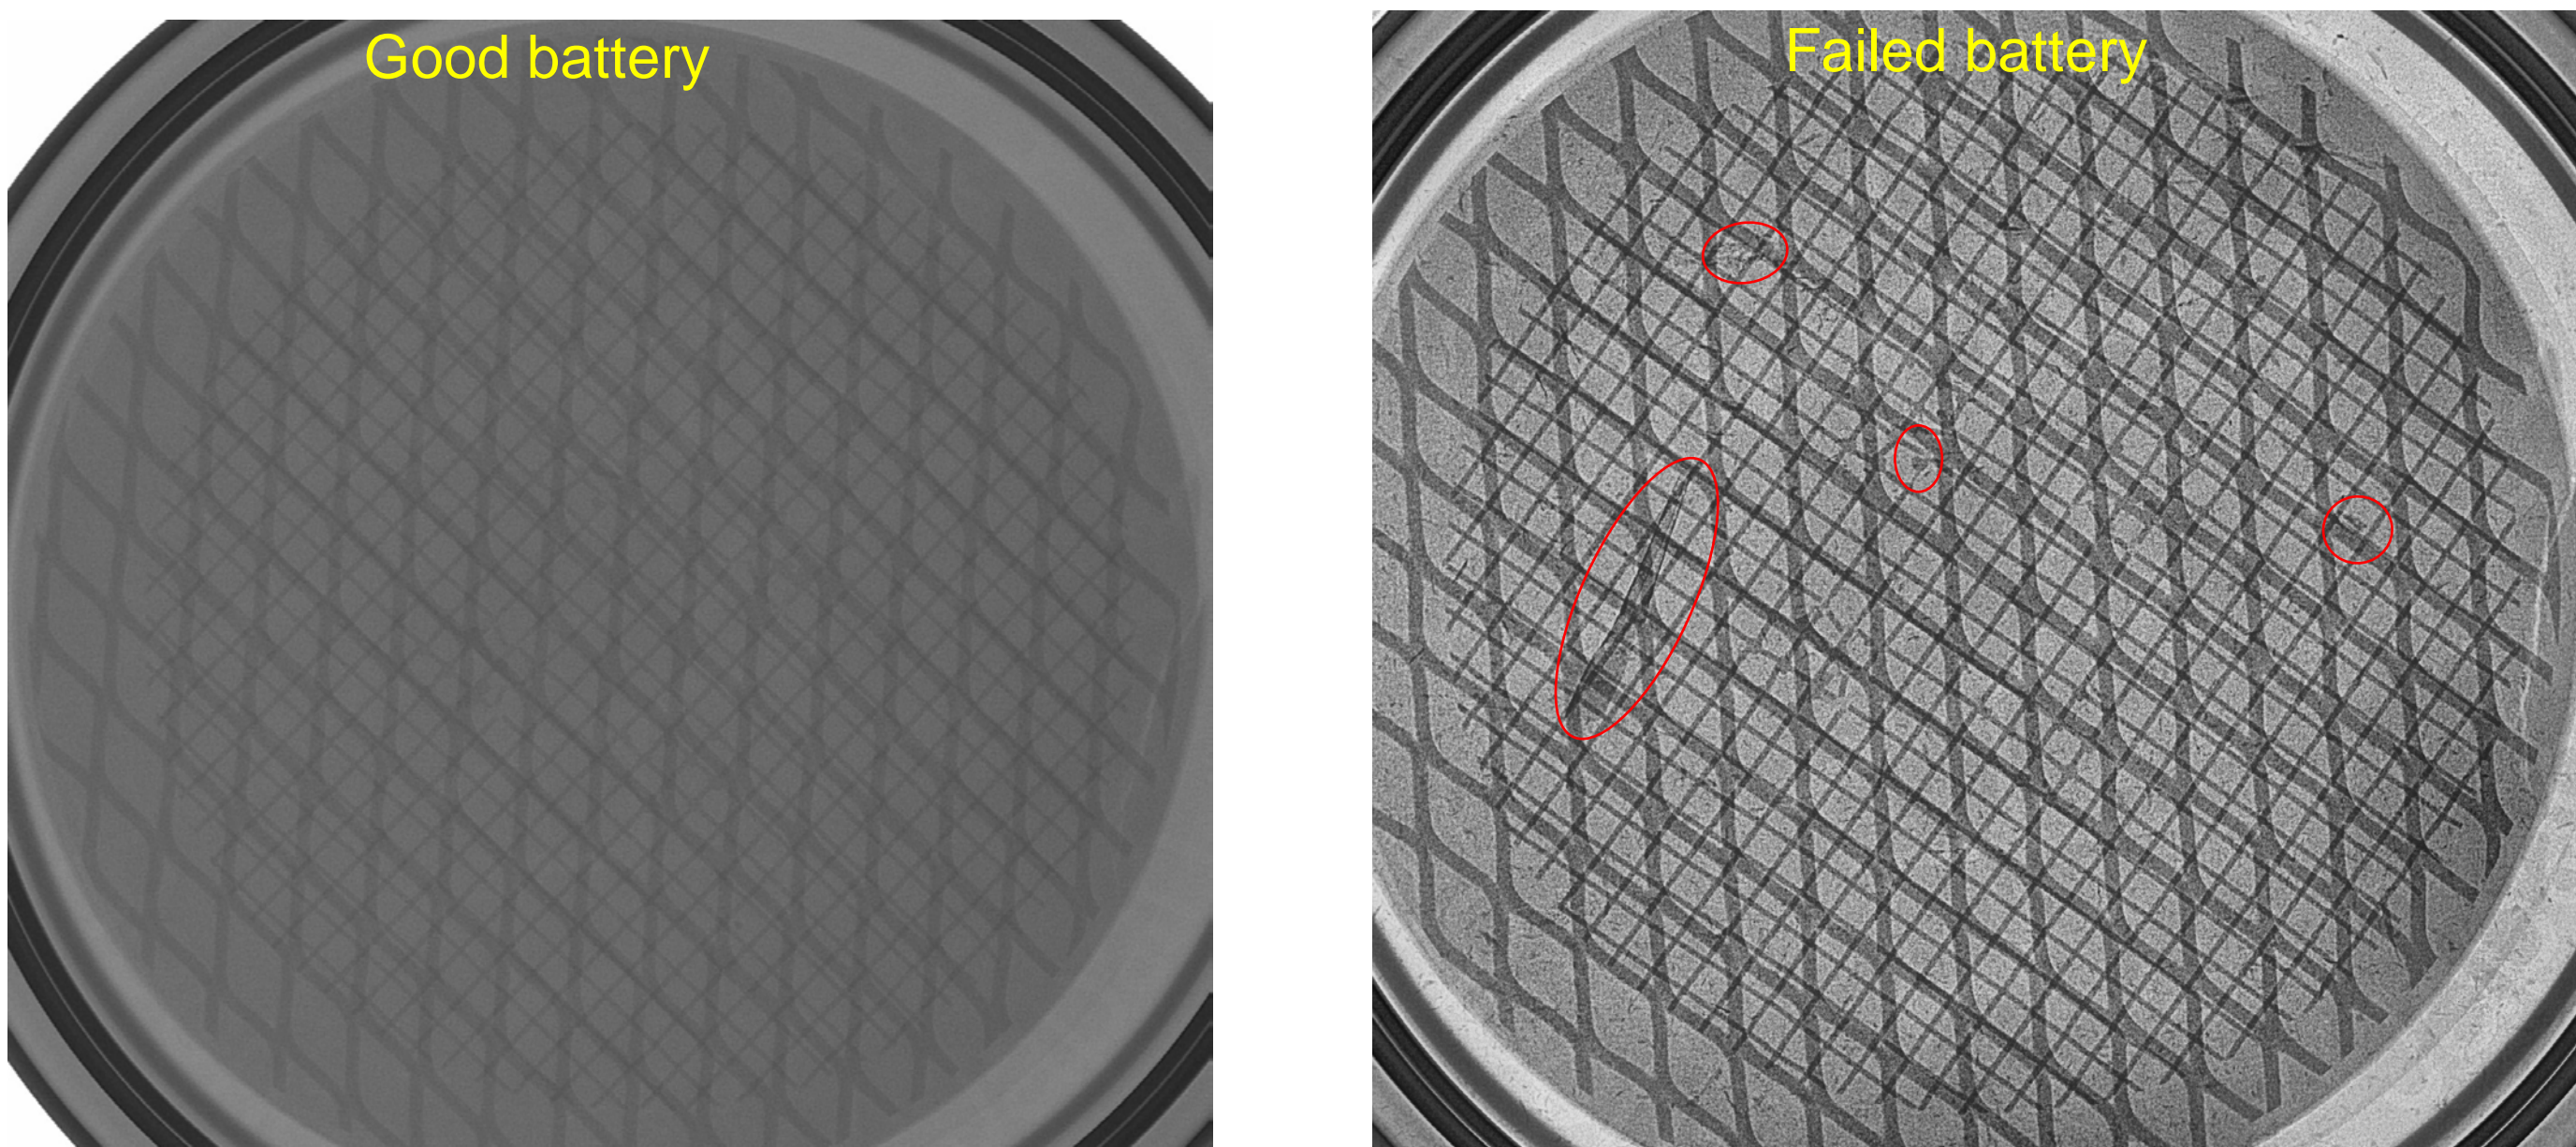
2D X-Ray:

The failed battery contains lots of impurity particles.

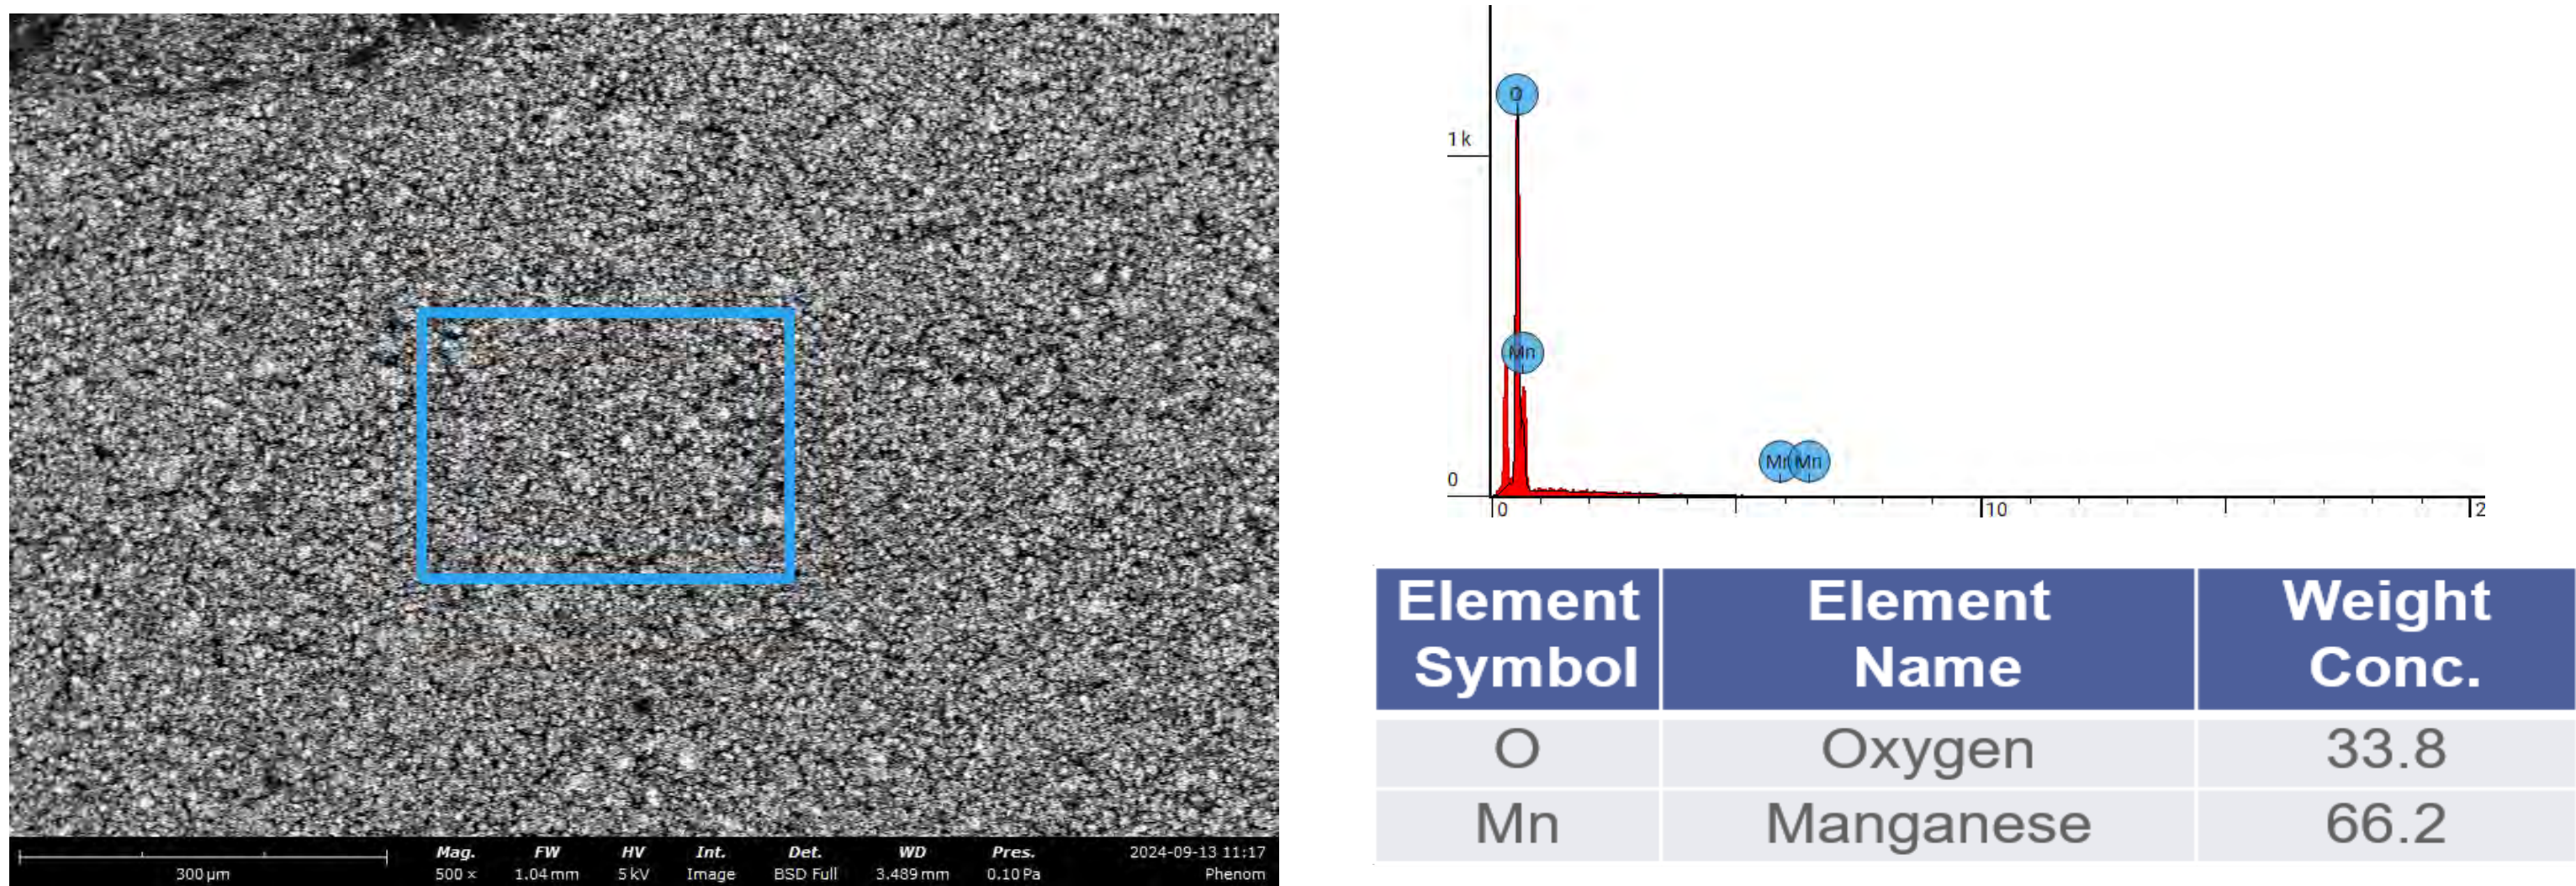
SEM/EDS of Cathode in the Failed Battery:

The cathode film from the failed coin cell did not display any visible impurities or defects.

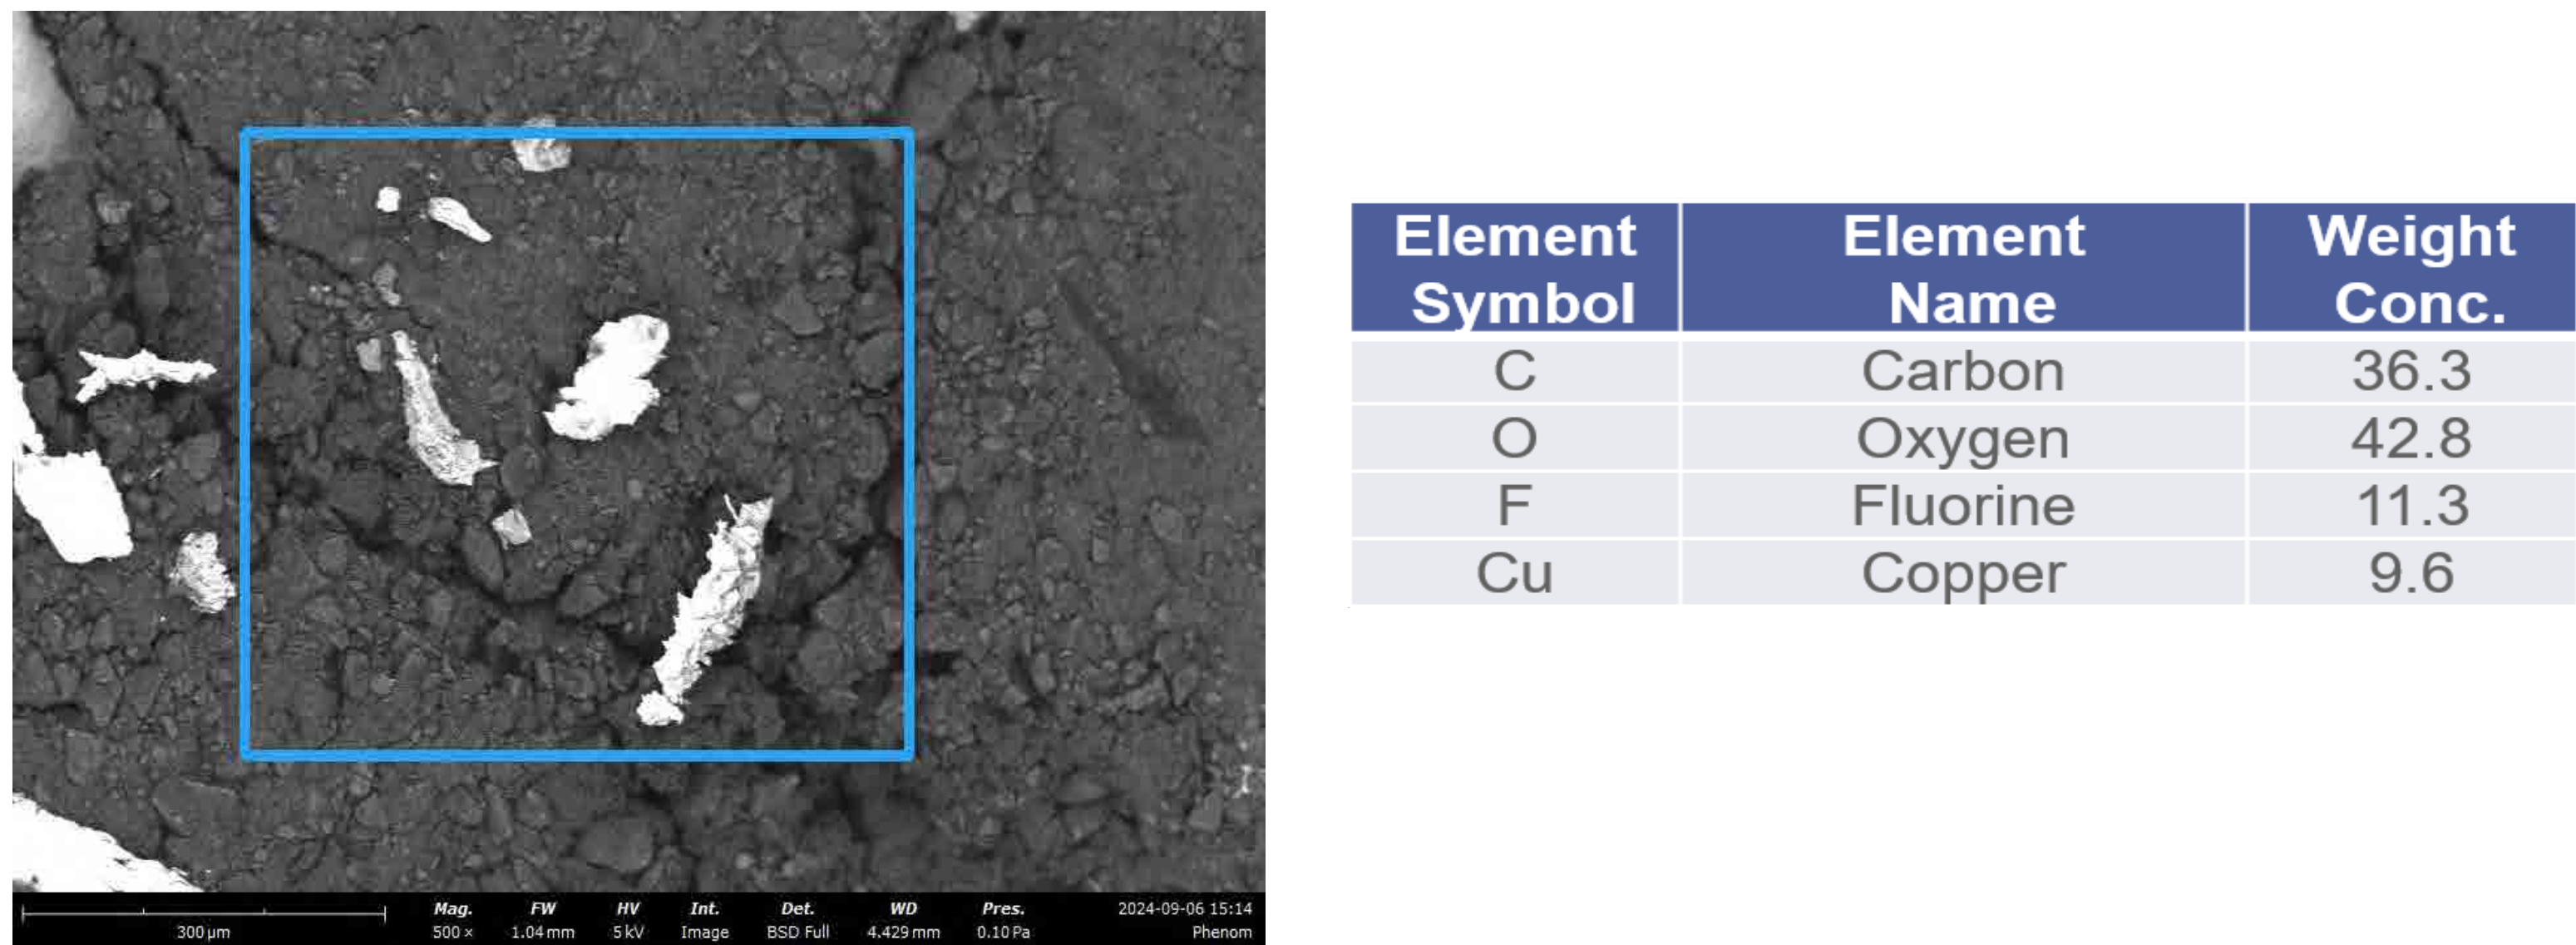
SEM/EDS of Anode in the Failed Battery:

The failed battery anode contains irregularly shaped impurities.

A failure analysis was conducted on a failed coin cell battery using several techniques, including 2D X-ray imaging, disassembly in a glove box, and airless transfer for SEM imaging with EDS analysis. The investigation revealed the presence of multiple metal particles within the anode of the failed battery, which were determined to be the cause of its failure.

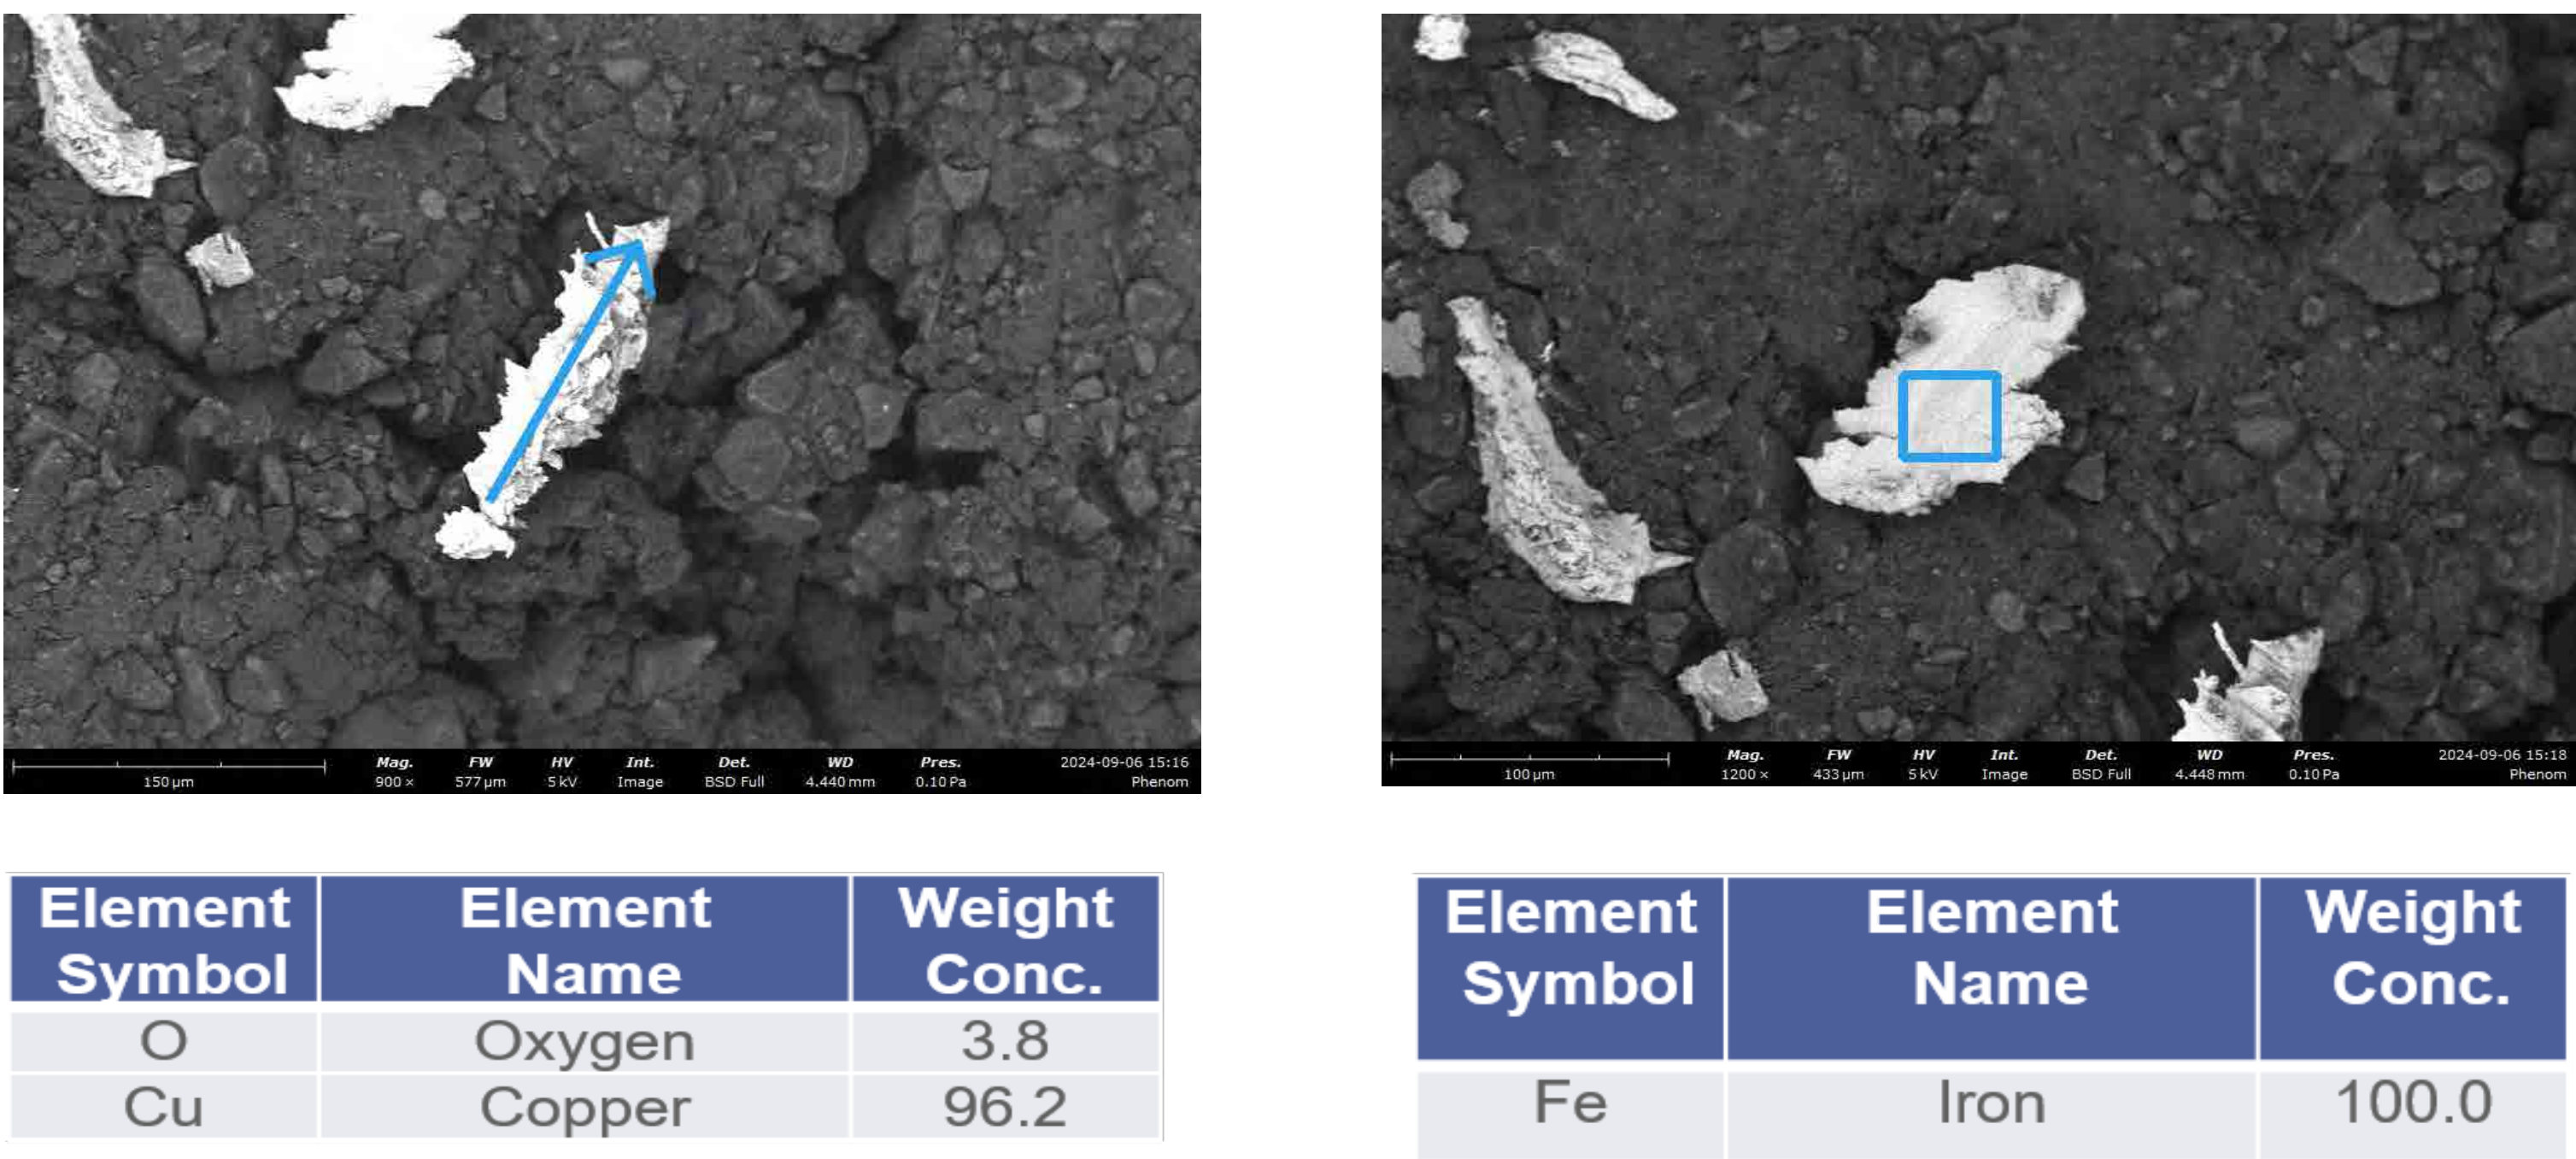
The impurity particles are composed of either Cu or Fe.
