APPLICATION NOTE

Identification of Interface Contamination Using Auger Electron Spectroscopy (AES)

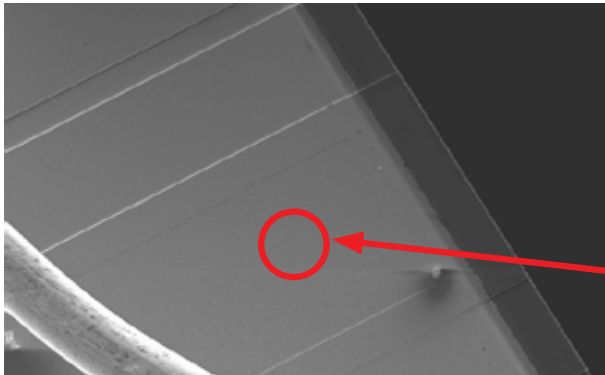
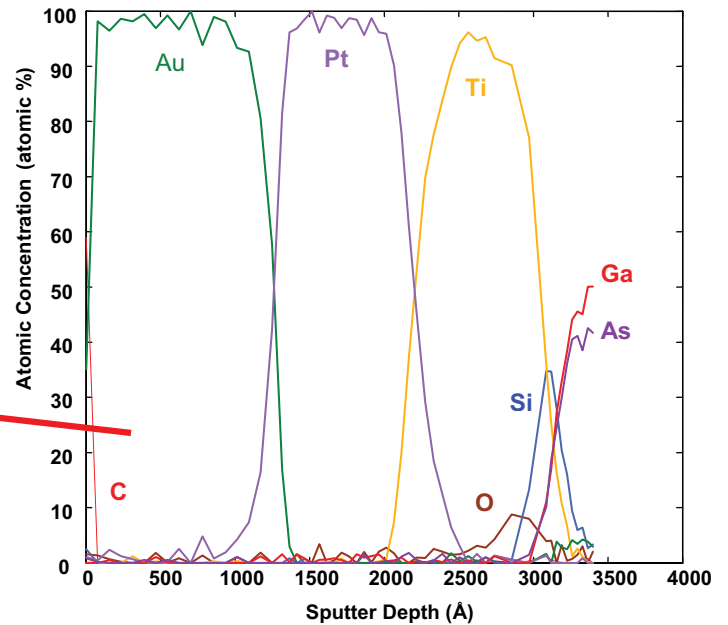
Example #1: Auger sputter depth profile acquired from a laser semiconductor device shows the presence of silicon at the Ti:GaAs interface. The source of the silicon was residual Si₃N₄.

The first example is a laser device that did not meet performance specifications. The facet coating was Au/Pt/Ti on GaAs. The region of interest is approximately 50 μm wide and several hundred μm long. An Auger depth profile was acquired from the center of the device as shown in the accompanying secondary electron image. Silicon was detected between the titanium layer and the GaAs substrate. The source of the silicon was identified as a remnant of silicon nitride that was not completely removed prior to the deposition of the titanium. The profile also shows some oxygen present in the titanium layer near the GaAs interface.

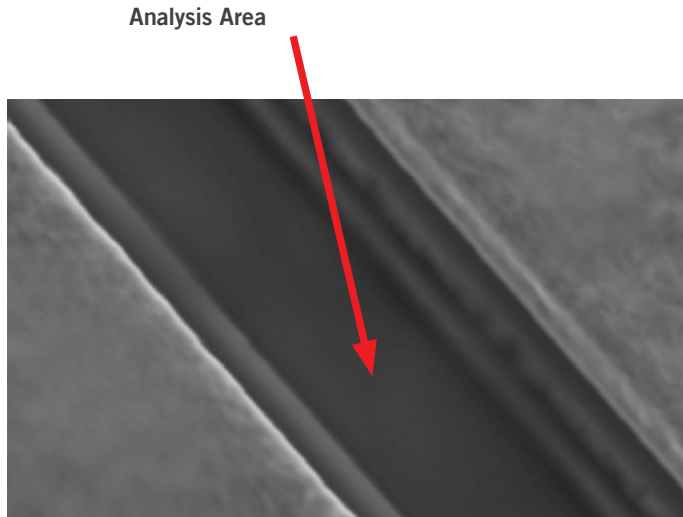
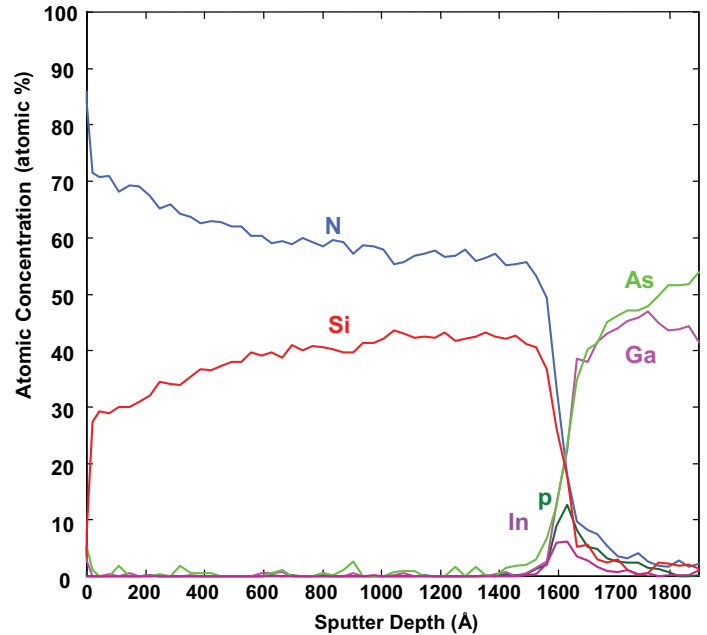
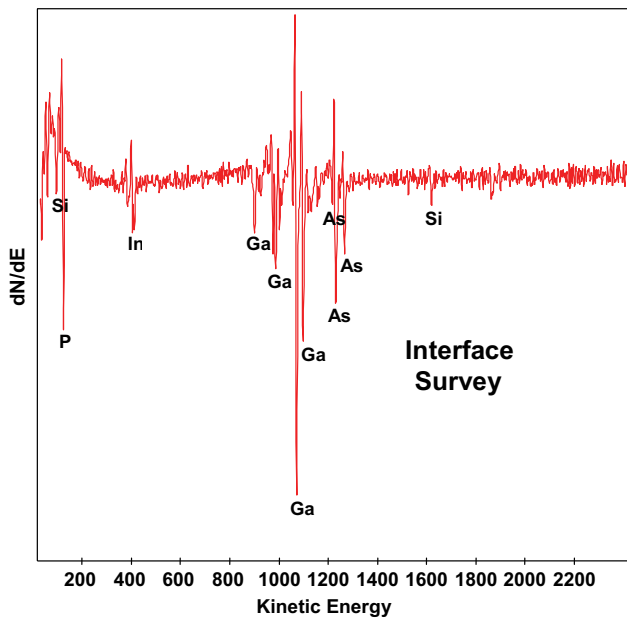
Example #2: Auger sputter depth profile acquired from a 1 μm^2 area shows the presence of indium and phosphorous at the Si_3N_4 :GaAs interface. The contamination was identified as residual InGaP etch stop.

In the second example, the objective of the analysis was to identify contaminants at a silicon nitride-gallium arsenide interface within a 1 μm^2 area. The depth profile was stopped at the silicon nitride-gallium arsenide interface so that a survey spectrum could be acquired. The profile and interface survey spectrum revealed

the presence of indium and phosphorous at the interface. The contamination was identified as residual InGaP which was used as an etch stop layer that was not completely removed during wafer processing.
