APPLICATION NOTE

# Medical Device Electronics: Improving Reliability with Auger Electron Spectroscopy

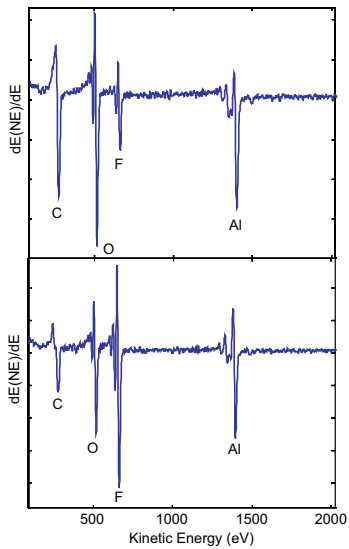
Figure 1a: Survey Spectrum from a normal Bond Pad  
Figure 1b: Survey Spectrum from a failed Bond Pad

Advanced electronics are pervasive in today's medical devices, from hearing aids to heart pacemakers and defibrillators. Reliable electronics performance is essential for the proper functioning of these critical devices. One aspect of the electronic circuitry that is sometimes problematic involves the integrity of wire or ball bonding to the metallic bond pads. Contamination and/or the presence of relatively thick oxide layers on bond pad surfaces can lead to poor adhesion and electrical connectivity of the wire or ball to the bond pad. The source of such bonding problems can be readily identified via Auger Electron Spectroscopy (AES) analysis. AES can be used effectively to monitor the cleanliness of the outermost surface of bond pads, as well as measure the thickness of the oxide layer thus identifying the probable cause of bonding problems. Figures 1a and 1b show AES spectra from good and poor-performing bond pads, respectively. The failed bond pads gave poor bond strengths during adhesion testing. The Auger data show a much larger concentration of fluorine contamination on the surface of the bad pad. These results led to a search for sources of fluorine contamination which was found on a foam material used

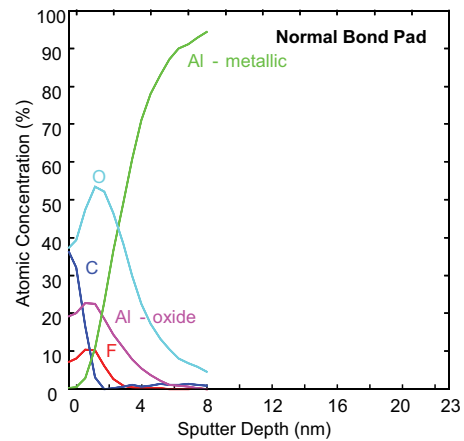
Figure 2a: Depth profile of normal Bond Pad, Al oxide ~4nm thick

In addition to the fluorine surface contamination, Auger depth profiles shown in Figures 2a and 2b reveal that the oxide layer is much thicker on the poor-performing pad compared to the good pad. Fluorine is detected throughout the oxide layer, indicating that the oxidation of the pad is catalyzed by the fluorine contamination.

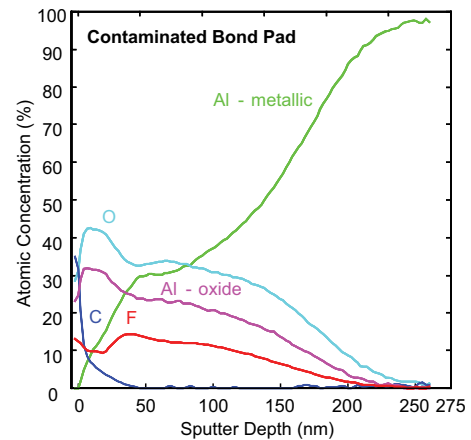
Figure 2b: Auger Depth profile of contaminated Bond Pad, Al oxide ~160nm thick
