## Pigmented Contact Lens

In this study, the surface and bulk of a commercially obtained pigmented contact lens (Fig. 1a) were characterized using the multi-technique approach available at Eurofins EAG Laboratories. The study, which included optical imaging, BSE (backscattered electron) cross-sectional imaging, XPS Depth profiling, and TOF-SIMS ion imaging, provided useful information on the pigment surface exposure and depth distribution.

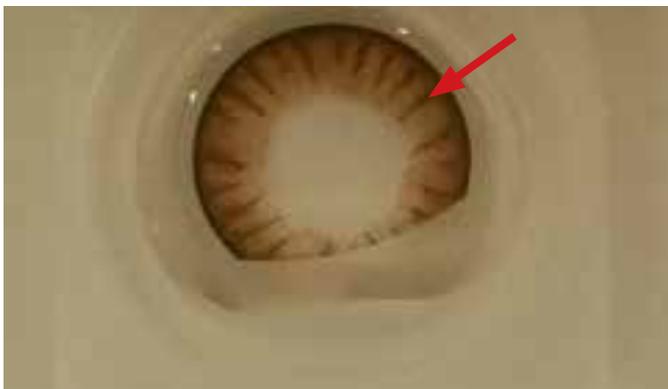
**Figure 1a.** This optical image shows the top view of a lens examined in this study. The red arrow indicates where the lens was sectioned for SEM analysis using a cryo-microtome with a diamond blade.

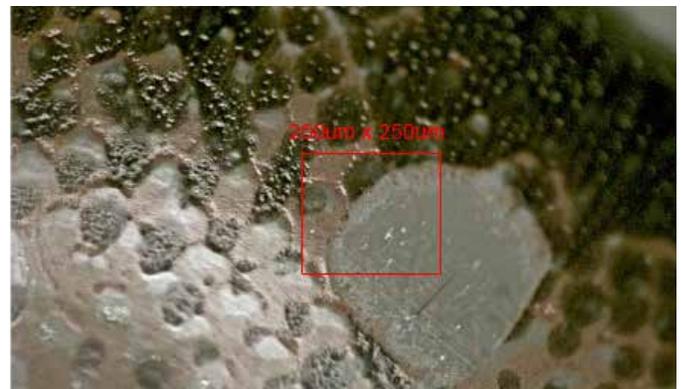
**Figure 1b.** The red box in this optical image shows location of the TOF-SIMS analysis.

The composition of the lens was unknown prior to the analysis. TOF-SIMS examination was performed on a grazing angle cross-section of the lens (Fig. 1b). The grazing angle broadened surface features for a more detailed analysis. HEMA (hydroxyethylmethacrylate) was identified as the base material of the lens and the near surface

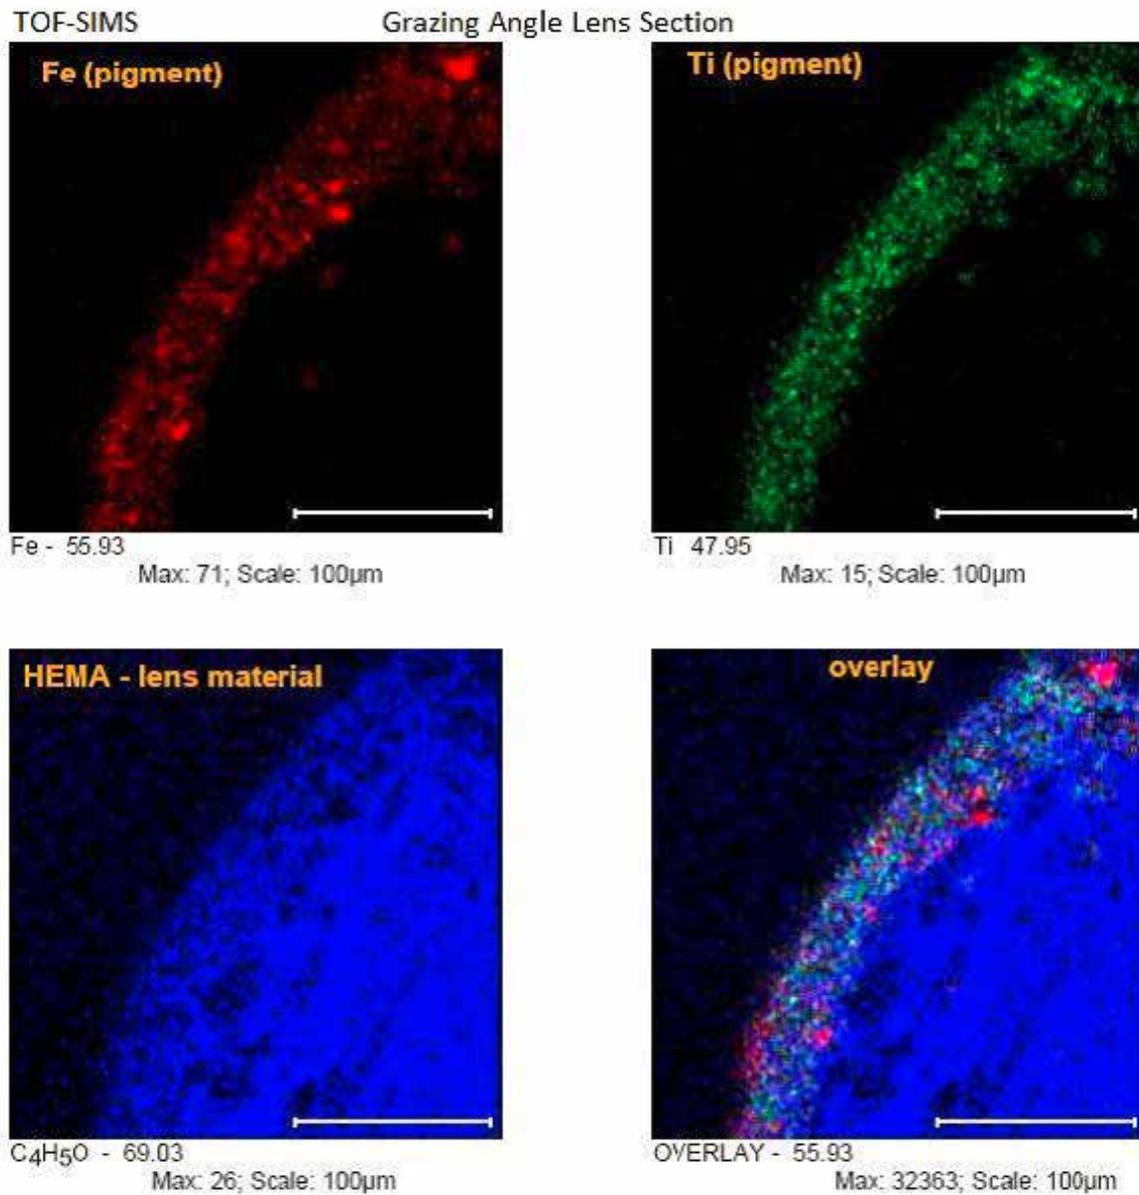
Figure 2. TOF-SIMS imaging of the grazing angle lens section shows the Fe oxide pigment (red), Ti oxide pigment (green) distribution and the HEMA (hydroxyethylmethacrylate) lens material (blue). Pigment signal at the surface of the lens was not evident.

had two pigment components, Fe oxide and Ti oxide, distributed as particulate (Fig. 2).

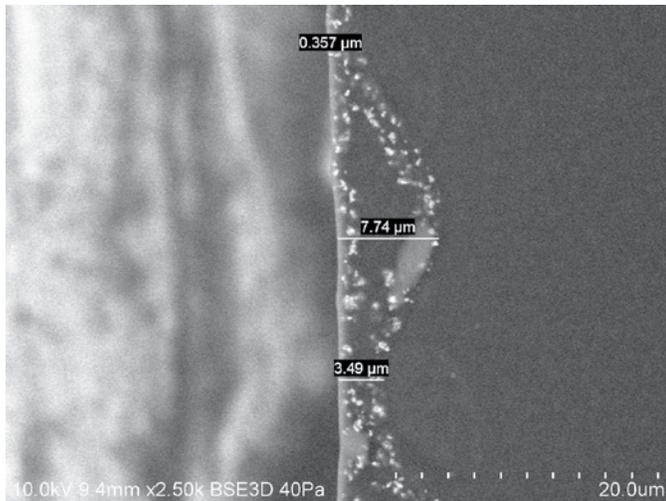
Figure 3. The BSE (backscattered electron) image of the normal angle lens cross-section (with the convex surface on the left side of the image) shows bright areas of Fe oxide and Ti oxide pigments reaching depths to 7.74 μm.

The BSE (backscattered electron) image (Fig. 3) of the normal angle cross-section helped to visualize the spatial distribution of pigments, present as particles of different sizes and distributed at various depths in different locations. The range of depth distribution of pigments obtained from the BSE image was approximately from 0.4 $\mu$ m to 7.6 $\mu$ m.

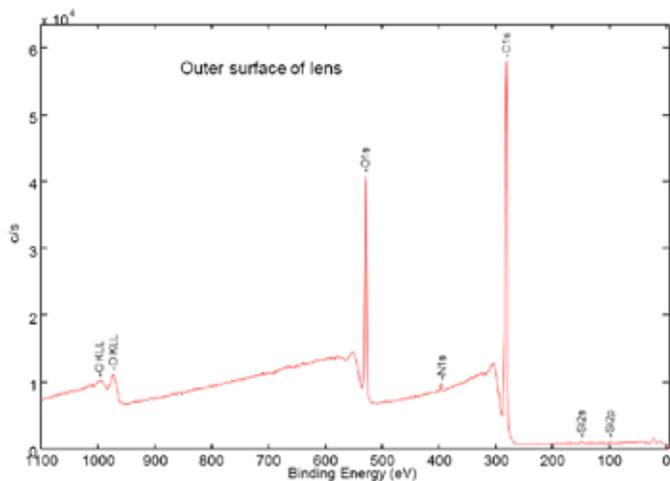
Figure 4. XPS survey spectrum of outer surface above the dark ring. No pigment specific species were observed.

The XPS analysis was started on the outer surface of the darkest circle near the circumference of the lens. Only carbon, nitrogen, oxygen, and silicon were detected in the surface survey spectrum, while no trace of pigment components were observed (Fig. 4). The XPS depth profile was carried out using a C<sub>60</sub> ion gun to minimize damage to organic materials during sputtering. The profile showed that the Fe oxide pigment was present at much higher concentration than the Ti oxide one (Fig. 5a). Additionally, the Ti oxide signal was not observed until much deeper than the Fe oxide (Fig. 5b). Both were found underneath the organic layer without any surface exposure.

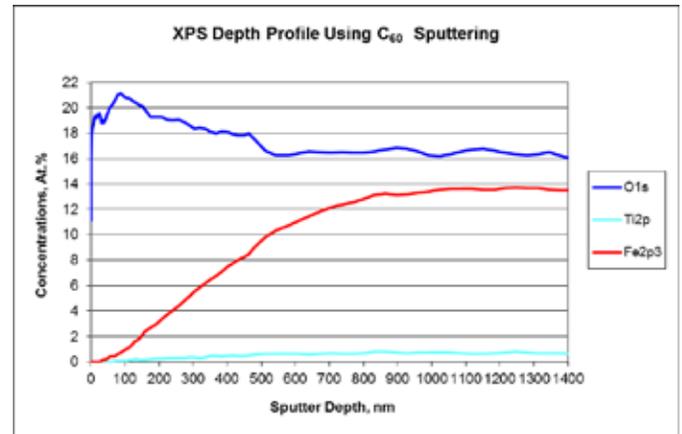
Figure 5a. XPS depth profiling shows the pigments are not exposed at the immediate surface, and the concentration of Fe oxide pigment is much higher than that of Ti oxide. The most abundant element of the lens material, C, is not shown in order to focus on the distribution of elements with lower concentrations.

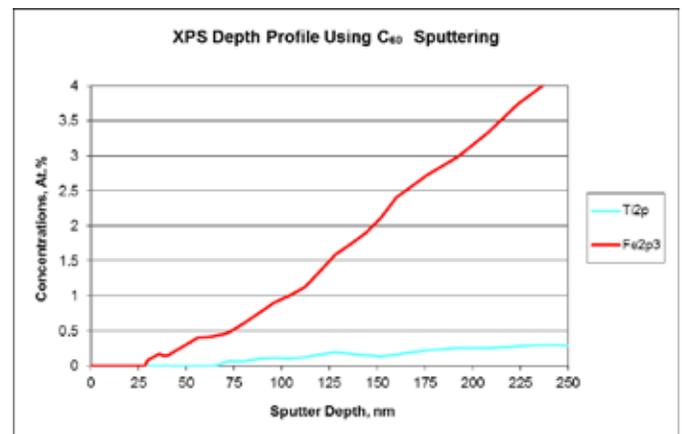
Figure 5b. The zoomed-in view of the XPS depth profile shows that Ti oxide pigment was distributed further from the surface than the Fe oxide.
