# Investigating Subsurface Defects: 3D EBAC Mapping with Varying Beam Energies

By **Shih-Lin Scott Lee**, Eurofins EAG Laboratories, Sunnyvale, CA, Shih-Lin.Lee@me.eurofinsus.com, 408-306-1914, www.eag.com  
**Lorenz Georg Lechner**, Kleindiek Inc., Pleasanton, CA, Lorenz.Lechner@kleindiek.us, 415-696-8195, www.kleindiek.us

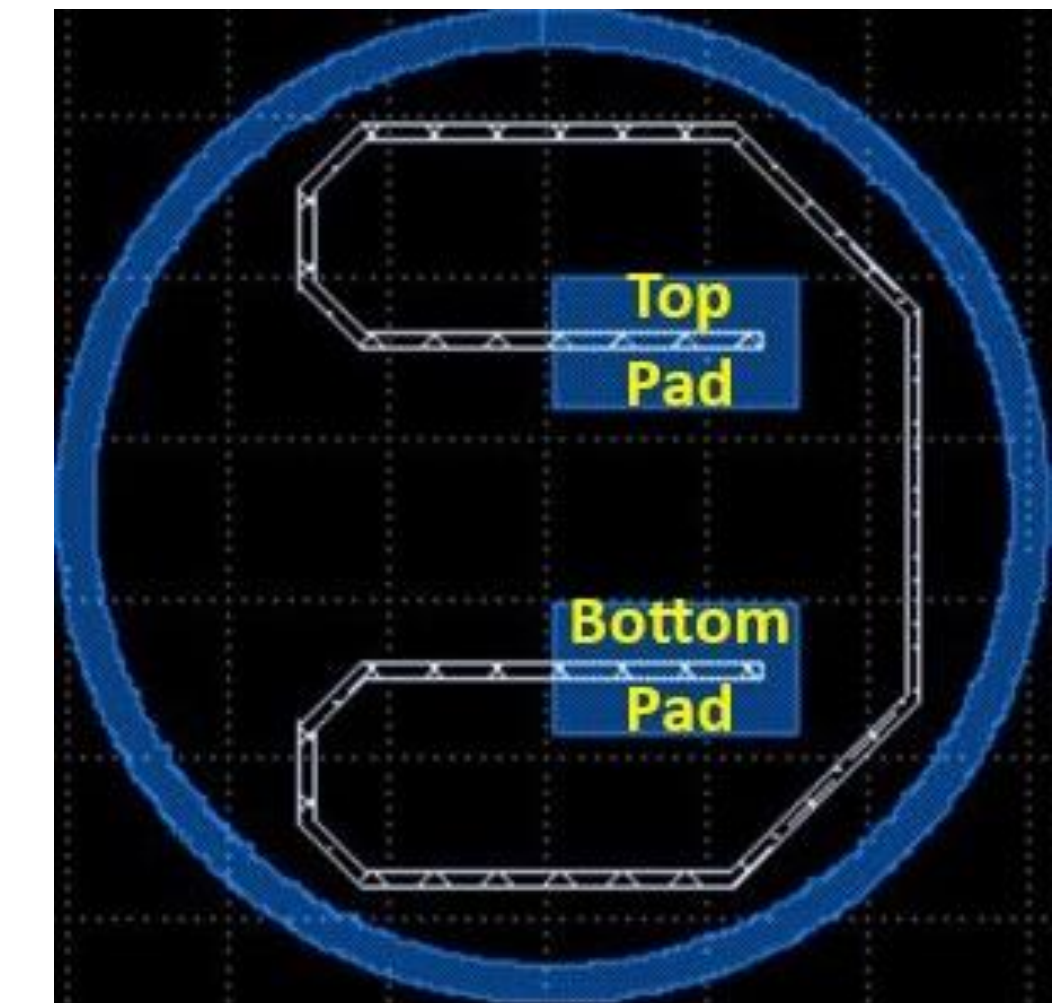
Illustration of the 2-terminal ring-shape structure

**SEM:** ThermoFisher NanoSEM 450  
**Nanoprobeing:** Kleindiek system with APT software  
**Analysis:** Keithley 4200A-SCS Parameter Analyzer  
**Sample:** Delayered to lower metal layers  
**Structure:** Two-terminal ring-shaped device

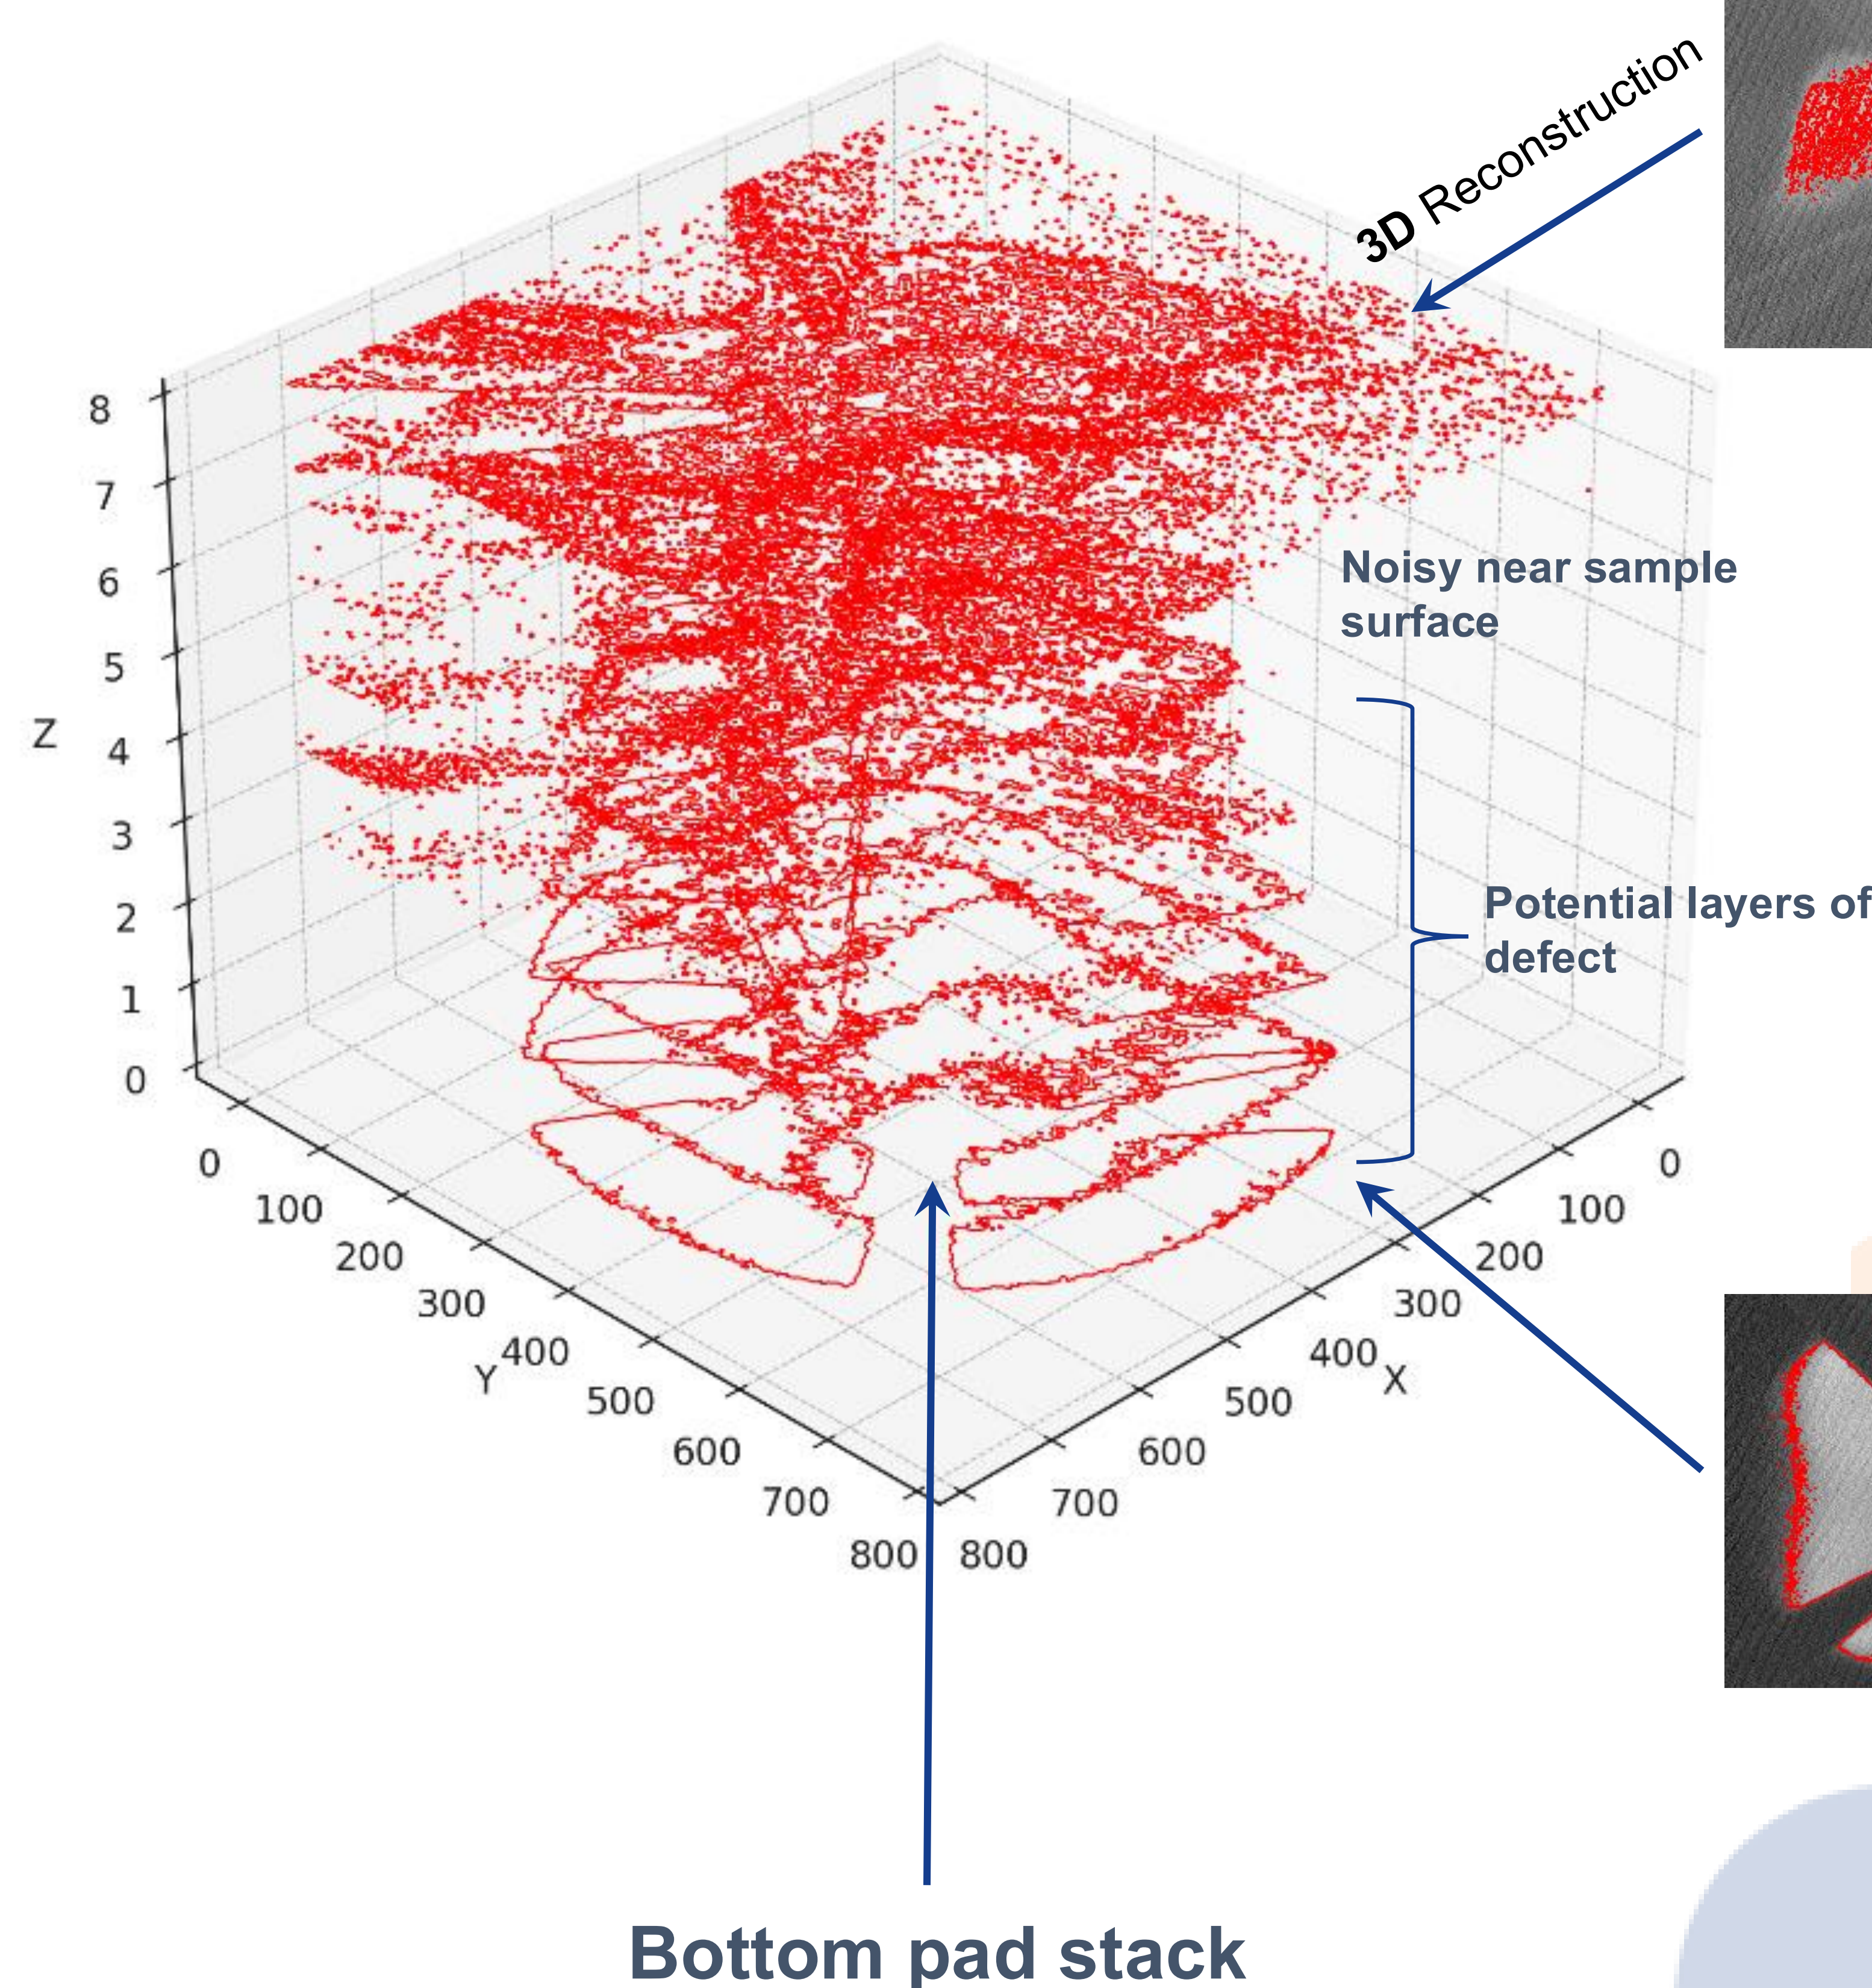
Extract contours or edges based on intensity gradients of the EBAC image

- Used multi-energy EBAC (2–10 kV) on the reference and the failing ring-shaped structures. (Only failing images were showing on the poster.)
- Captured EBAC images from current amp connecting to top and bottom pads.
- Extract contours or edges based on intensity gradients of each EBAC images.
- Built 3D reconstructions from stacked images to analyzing the defect layers.

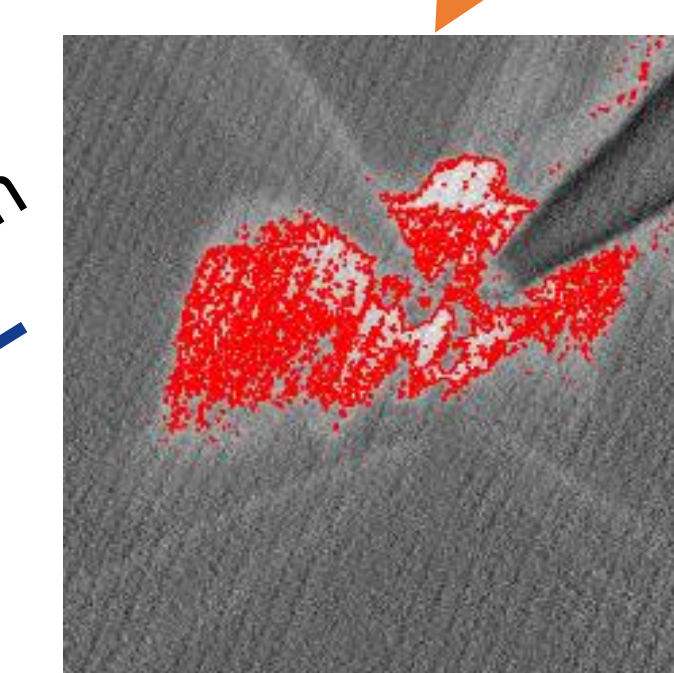
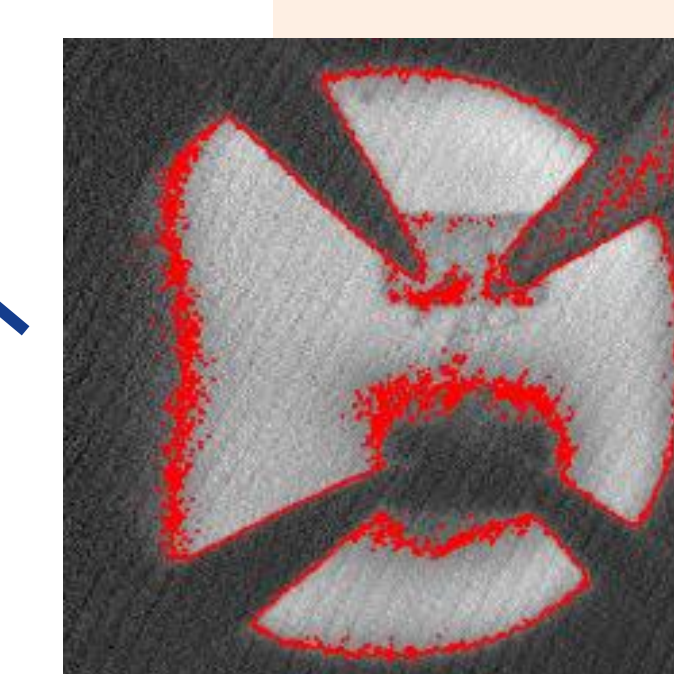
- Low kV: highlights surface features.
- High kV: probes deeper conductive layers.
- 3D reconstruction showed high noise level at upper layers of pad stacks.
- The open and high-resistance anomalies were most likely near the lower layers of the bottom pad stack.
