APPLICATION NOTE

# Cause and Location of Delamination of Multi-layer Metal Foil by XPS

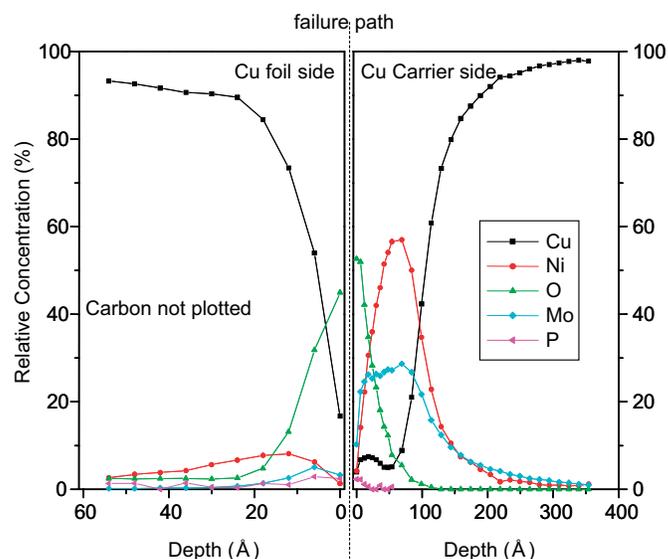
To probe the thickness of the Ni, Mo and P containing layers, the exposed surfaces were depth profiled using an argon ion beam. The resulting profiles reveal a roughly 10Å thick phosphate layer on both sides of the failed interface. The P concentration is relatively low (2.5%); however, it was determined to be present as PO<sub>4</sub><sup>3-</sup>, meaning the total amount of phosphate at the interface is >5X the P concentration. The cation associated with the phosphate was likely either Cu, Mo or possibly H (hydrogen is not detected by XPS). Beneath the phosphate layer on the Carrier side was a ~100Å thick Ni<sub>2</sub>Mo layer. A small amount of Ni was detected on the mating foil surface.

XPS was used to determine that adhesive failure occurred at a Ni<sub>2</sub>Mo-Cu interface as a result of a high concentration of phosphate (see schematic in lower right).

**Schematic of laminate structure and failure location based on XPS data**
