Failure Analysis of Particle Contamination in Battery

By Yuanqin (Daniel) Liu, Kelly Prochaska, Dogancan Sari, and Dr. Daniel J. D. Sullivan, Eurofins EAG Laboratories, Sunnyvale, CA, USA
www.eag.com

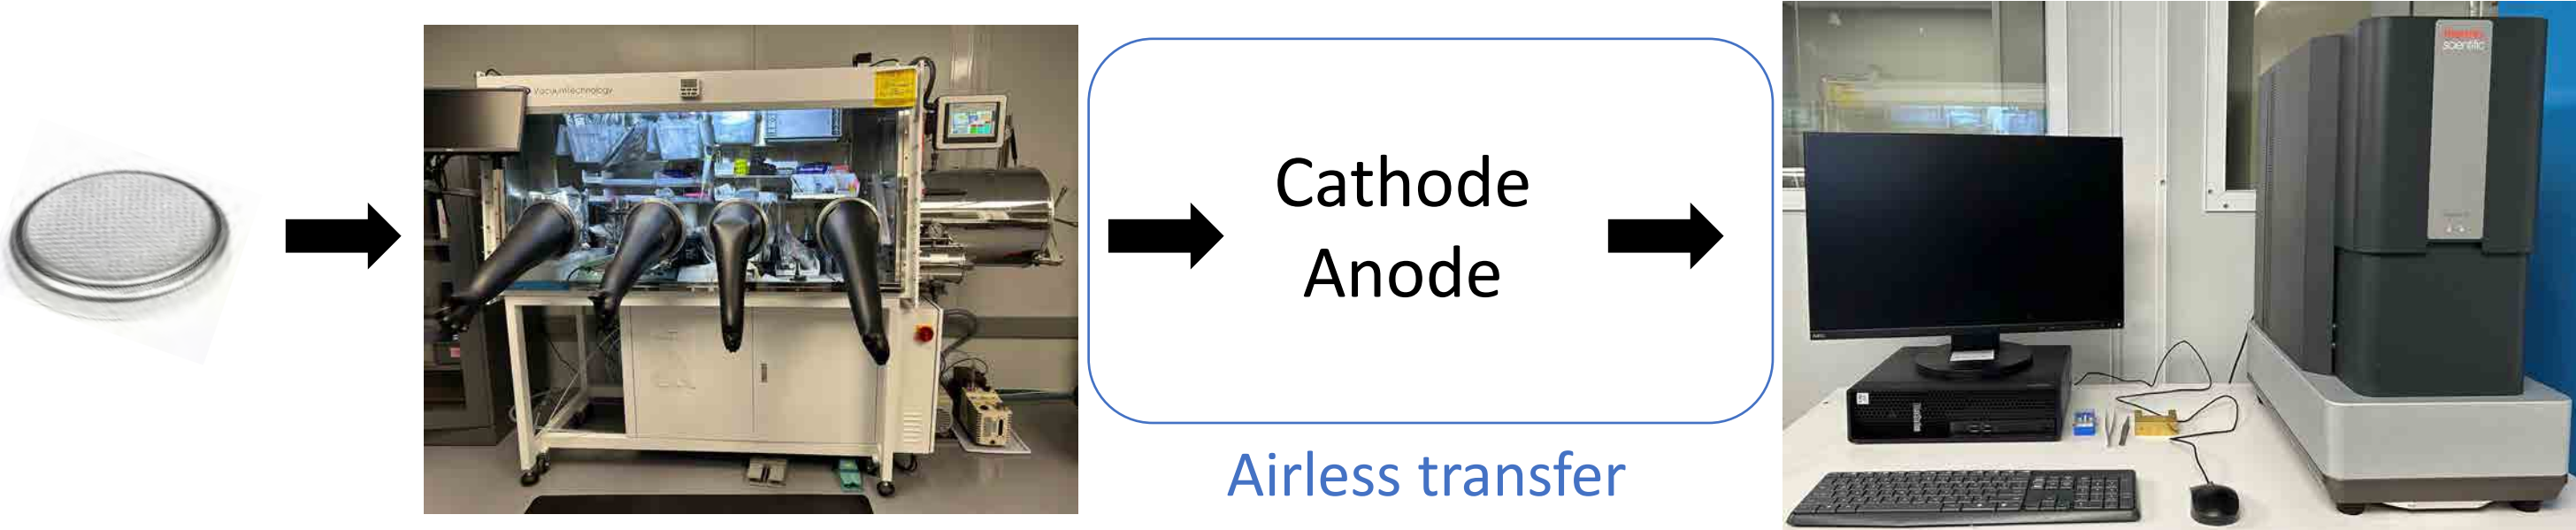
Battery Disassemble:

The two coin cells were disassembled in an argon glove box. Cathode and anode films were isolated from the cells and washed with dimethyl carbonate (DMC) a few times to remove electrolyte before being mounted on an airless transfer container for SEM/EDS imaging. .
