EAG Laboratories

APPLICATION NOTE

# Application of Electron Microscopy to Lithium-ion Batteries I: A Cell Phone Battery

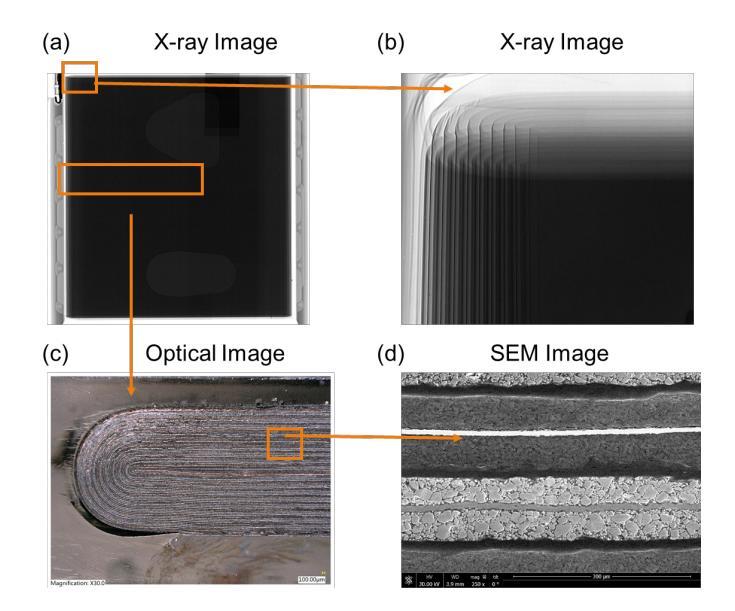
In this application note, multi techniques were used to characterize a lithium ion battery from a cell phone including X-ray imaging, SEM/EDS and AC-STEM/EELS. X-ray image shows the battery has a jelly roll structure (Fig. 1a, b). Multi layers were observed on the cross-section images (Fig. 1c, d) by optical microscope and SEM. Based on SEM/EDS results, there are carbon-based anodes on both sides of Cu current collector. Cathode is consisted of Co and O on Al current collector. Between the anode and Cathode, is the polymer-based separator (Fig. 2).

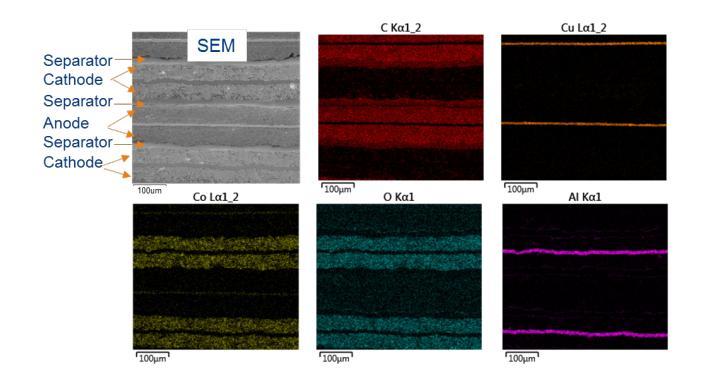
Figure 2. SEM image and EDS elemental maps of phone battery shows the presence of C on Cu current collector in Anode, and Co/O on Al current collector in Cathode.

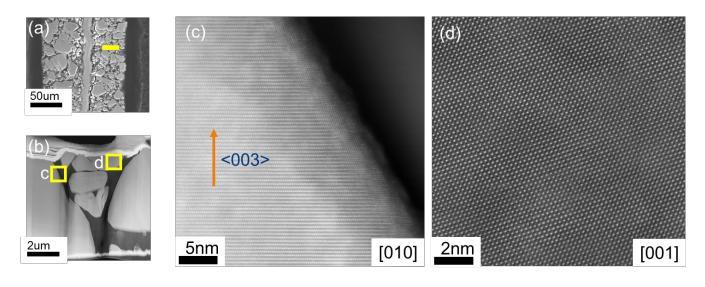
Figure 3. (a) SEM image shows the cathode particles size in the range of a few um to tens of um. (b) STEM image and (c, d) atomic HAADF images from the two regions labeled inside image (b) from two grains with different orientation.

The cathode is consisted of grains with size from a few um to tens of um (Fig. 3a). In order to get more information about the cathode materials, TEM samples were extracted from the cathode film (Figure 3b). AC-STEM images (Figure 3c, d) show the materials has good crystalline structure. Figure 3c and d show two grains with different orientation. Image (c) clearly show the layered structure along the 003 direction. While image (d) is from another direction to show the atom arrangement in a-b plane. The surface of the grain shows a different structure from the core part even from a fresh new phone battery.

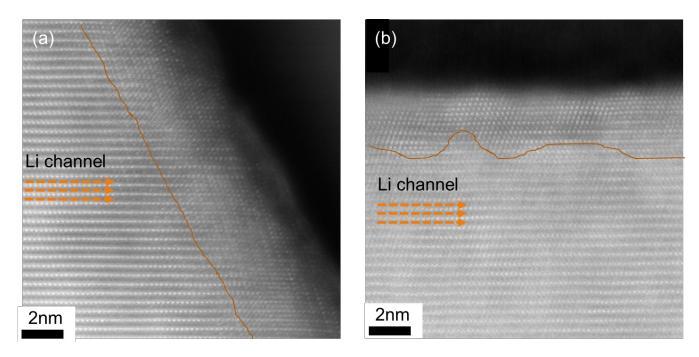
Figure 4. HAADF images from the grain with surface: (a) at the end of the lithium channels and parallel to the lithium channels.

Atomic level HAADF image clearly shows the surface structure changed from the core layered structure to rock-salt structure (Figure 4). The bright spots in the HAADF images here are the Co atom column. Li channels are between the Co layers, however not visible in HAADF image. As shown in the image (Fig. 4a), Co atom moved into the lithium positions at the surface and blocked the Lithium channel. Once the Co completely entered the lithium positions, the layered structure changed into a rock-salt structure. At the surface that is at the end of the Li channels, such rock-salt structure is uniform with a flat interface with the core layered structure (Fig. 4a). At another surface that is parallel to the lithium channels, the surface also has a rock-salt structure. At this direction, the interface between layered structure and rock-salt structure is rough with steps (Fig. 4b). The transition mechanism from core layer structure to surface rock-salt structure at these two surfaces is different. The formation of the strain will be direction depended on the uniform or rough interface, and lead

to the formation of crack eventually. This surface rock-salt layer protects the particle from further degradation, but it also reduces ionic and electronic conductivity.

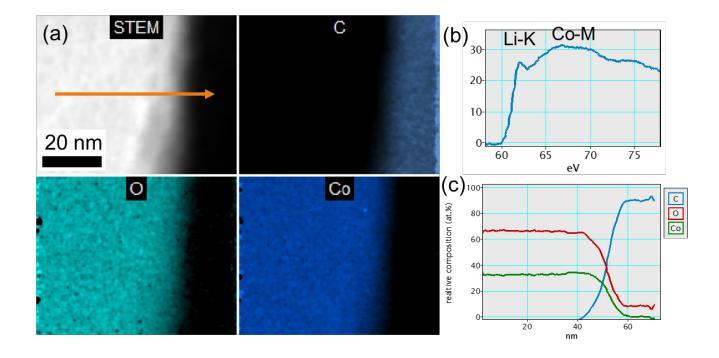
Figure 5. (a) STEM image of a part of a cathode particle shows the presence of the O and Co. (b) an EELS spectrum from the core area shows the Li K edge overlaps with Co-M edge. (c) line profile across the yellow line in (a).

EELS confirmed the presence of O and Co inside the cathode oxide as shown in the elemental maps (Figure 5a). An EELS spectrum from the core part of the particle also confirm the presence of the lithium as indicated by Figure 5b. Line profile (c) along the yellow line in (a) shows the O/Co is around 2. Based on such results, the cathode oxide is determined to be  $Li_xCOO_2$ .

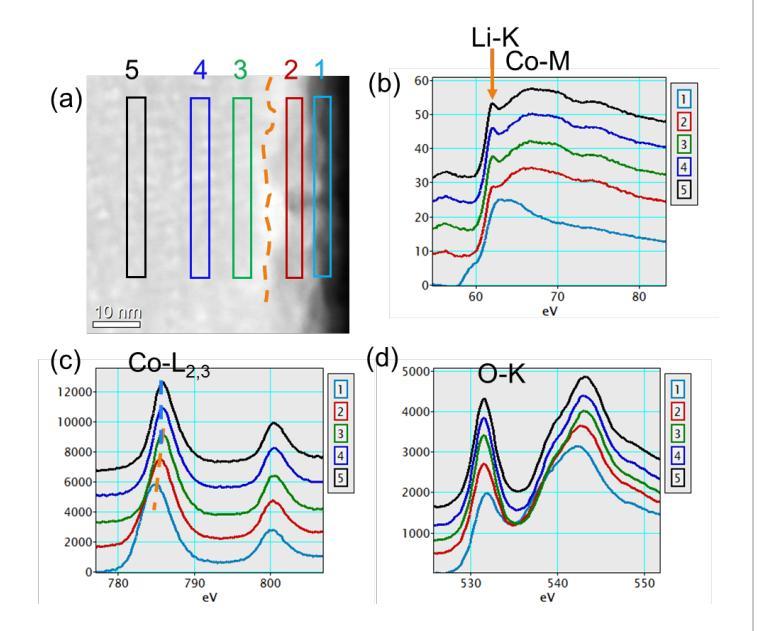
Figure 6. (a) STEM image of a cathode particle surface. (b) Li K-edge, Co M-edge, (c) Co L-edge and (d) O K-edge at different locations as labeled inside image (a).

For the rock-salt surface, EELS near edge fine structures revealed the change of Li, Co and O at different positions of the surface (Fig. 6a). As shown in Fig.6b, no Li was detected at the surface of the rock-salt layer. At the surface, Co L edge shifted to lower energy loss which means the Co's oxidation state changed (c) and was reduced to a lower valence state. By comparing the edge position and shape, the Co from surface changed into CoO. The prepeak of O from the surface area is much lower than that from the core area, which indicates the formation of oxygen vacancies (d). The loss of oxygen also supports the phase change from Li<sub>2</sub>CoO<sub>2</sub> to CoO. The formation of CoO is likely starting with the extraction of lithium during charging, then the Co moved into the empty lithium position, at the same time, oxygen gets released. Such CoO phase will block the lithium moving in and out, increase the ionic and electrical resistance of the lithium ion battery, and is responsible to the irreversible capacity loss.
