Failure Analysis of Polymers

- Raw materials in polymer formulations
- Adhesives (heat/moisture/UV-cured, silicones, epoxies, acrylates)
- Coatings (functional or decorative)
- Thermoplastics, thermosets, thermoplastic elastomers, composites
- · Molded, extruded, cast components

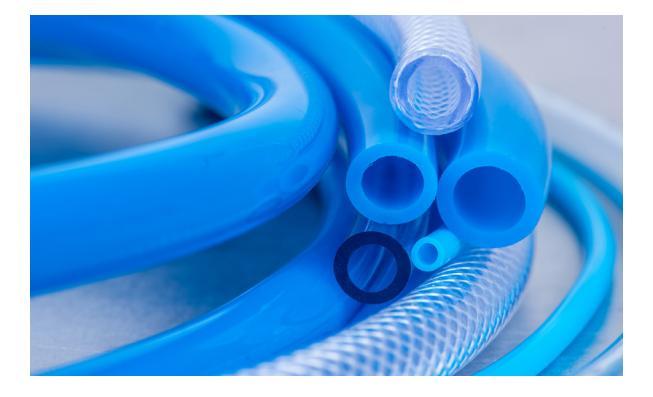
A device manufacturer observed defects in a specific lot of thermoplastic tubing. The tubing exhibited signs of dimpling and axial deformation, suggesting chemical attack or exposure of the tubing to localized heating.

TGA was performed to compare weight loss profiles as a function of temperature. The defect tubing had a significantly lower decomposition onset temperature compared to the control tubing. Additionally, the deformed tubing exhibited multiple weight loss steps compared to a single major weight loss step for the control. DSC profiles in the 1st heat scan (as-received thermal history), cooling scan, and 2nd heat scan (inherent properties) were also different.

Results indicated a compositional difference between the defect and control tubing materials, consistent with exposure of the defect tubing to an incompatible chemical.

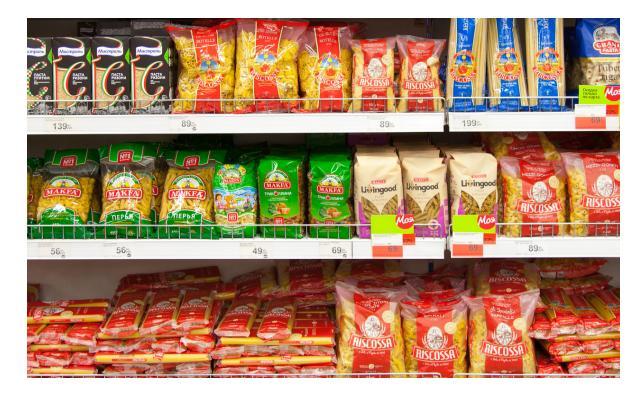
A client wanted to investigate the failure of a multilayer laminate used for food packaging. Lots of roll stock did not meet the seal strength specification; bad lots exhibited seal strengths that were an order of magnitude lower than the known good lots. Cross-sections of samples from the seal strength test were prepared using a cryo-microtome. The failure location for samples analyzed from good and bad lots were different; laminates that failed the test exhibited a mixed mode failure of the adhesive between polyolefin and polyester layers, whereas laminate that passed the test delaminated between the foil and polyester layers. Based on pyrolysis GC-MS of the adhesive, polyurethane species were detected in the desorption step for the bad lots and only in the pyrolysis step for the good lots. In addition, the adhesive from the bad lots had lower average molecular weight values and a higher polydispersity index.

Results indicate that the reduced seal strength was due to degraded adhesive in the bad laminate lots.

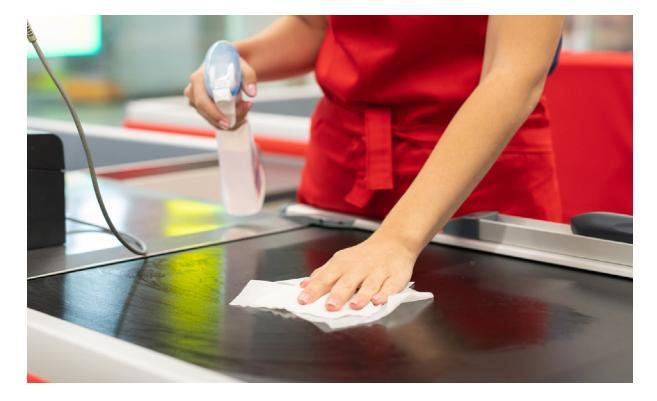
A company was investigating a rise in cracking of polycarbonate (PC) components used in a conveyor device that was frequently sanitized with disinfectants. The components were reportedly exposed to a disinfectant product containing quaternary ammonium compounds, which have been known to cause environmental stress cracking (ESC) of polycarbonate materials under certain conditions.

Fractography was performed on the failed components to assess the failure mode based on the crack morphology and fracture surface features. The components were severely embrittled and the fracture surface features were consistent with ESC. Additionally, the components were extracted with a solvent and screened by LC-MS for non-volatile organic compounds.

Based on the mass spectral signal, ions consistent with a benzyl quaternary ammonium compound were detected, confirming PC components were in contact with a known stress cracking agent.
