APPLICATION NOTE

Glass Delamination in Pharmaceutical Vials Related to Surface Chemical Changes

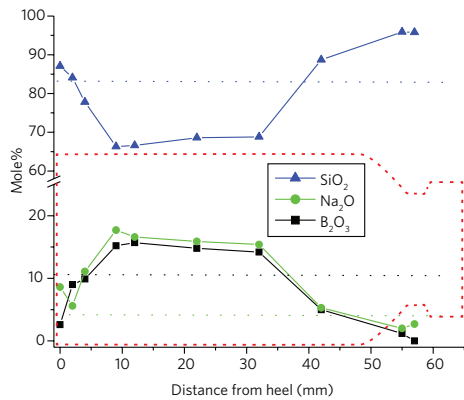
Figure 1: Measured surface (top 5 nm) composition along the length of an as formed vial. Note the B_2O_3 and Na_2O depletion near the bottom and shoulder of the vial where high forming temperatures lead to volatilization. Horizontal dotted lines represent bulk glass composition.

Figure 1 shows the surface composition of a Type I glass vial as a function of position along the vial length. For reference the bulk composition for each oxide is shown as a dotted line. The B₂O₃ and Na₂O are depleted at the ends of the container and enriched along the sidewall. The cause of this compositional variation is likely due to volatilization of Na and B species from the areas experiencing the highest temperatures during forming (bottom and shoulder) and condensation at areas not exposed to such temperature extremes. A depth profile acquired 10 mm from the heel (Figure 2) shows the B and Na enriched layer extends ~80 nm into the glass.

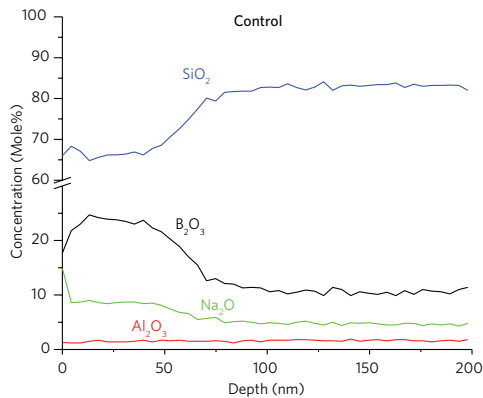
Figure 2: Depth profile of an as formed glass vial showing B_2O_3 and Na_2O enriched layers.

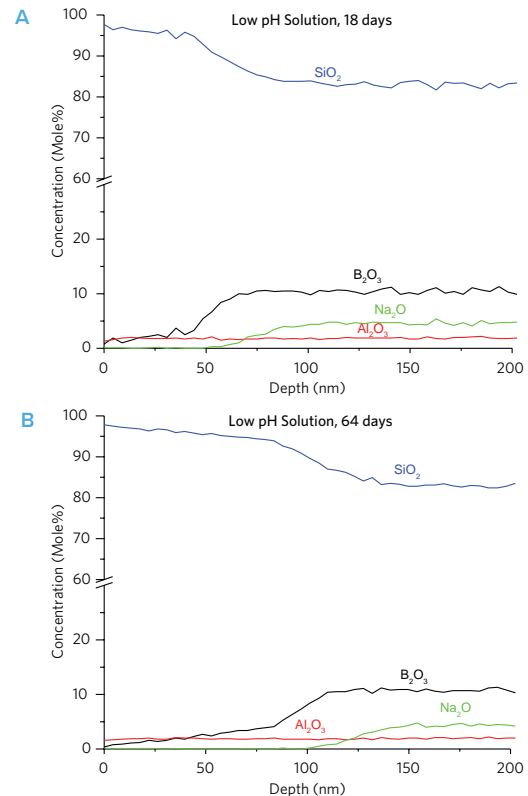
Figure 3: Exposure to low pH solution for 18 days and 64 days leads to the creation of layer depleted in B and Na and the formation of a silica-like surface layer.

Glass corrosion mechanisms are different depending on the pH of the solution. Vials from the same lot of material were exposed to both low (acidic) and high (alkaline) pHs. Figures 3a and 3b show depth profiles of vials exposed to a low pH solution for varying times. An 80 nm thick B and Na enriched layer, after initial forming, (Figure 2) becomes a 50-100 nm depleted layer after exposure to an acidic solution for 18 days (Figure 3a). Not surprisingly, increasing time of exposure leads to a thicker depletion layer (Figure 3b). ICP-MS (not shown) confirmed elevated levels of Na and B in the stored solution, compared to levels in the solution at the start.

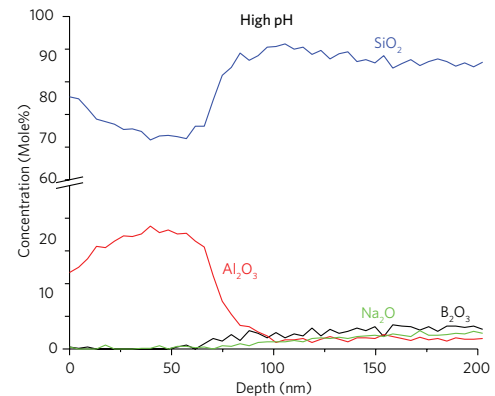
Figure 4: Depth profile of a vial exposed to a high pH solution

At high pH, the mechanism of corrosion in silicate glasses is fundamentally different than at low pH. Rather than removal of modifying species, the Si-O-Si structure of the glass dissolves. The surface of a vial exposed to high pH contains a 75 nm Al_2O_3 -rich layer. The Al_2O_3 concentration (>10 mole%) was found to be significantly higher than in the bulk (Figure 4).
