HOW DO YOU REMAIN THE LEADER  
IN FAILURE ANALYSIS SERVICES?

## Now offering the complete X-ray inspection solution

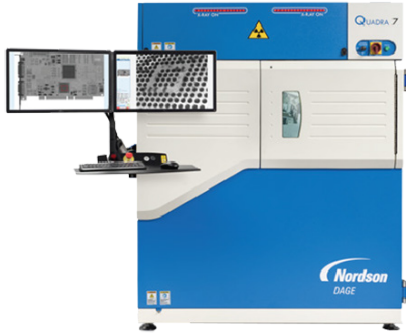
Quadra™ 7 represents the cutting edge of X-ray inspection performance. 6.7 MP ultra high quality images are displayed at full one-to-one resolution over two 4K UHD monitors, ensuring you see the clearest features today, and for all your products in the future.

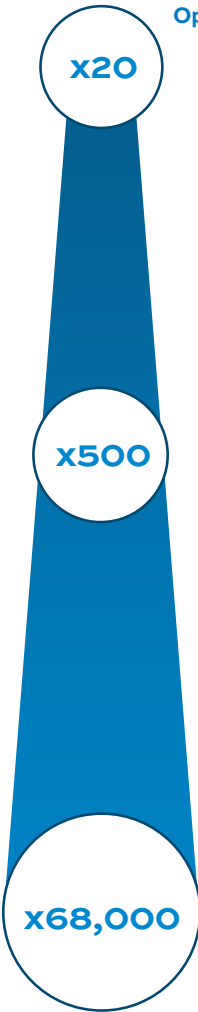
Optical → X-ray
